OHIO RIVER BASIN
FOUR-MILE RUN, WESTMORELAND COUNTY

PENNSYLVANIA
FOUR-MILE RUN DAM

NDS I.D. No. PA - 00457
PENNDER I.D. No. 65 - 126

PHASE I INSPECTION REPORT
NATIONAL DAM INSPECTION PROGRAM

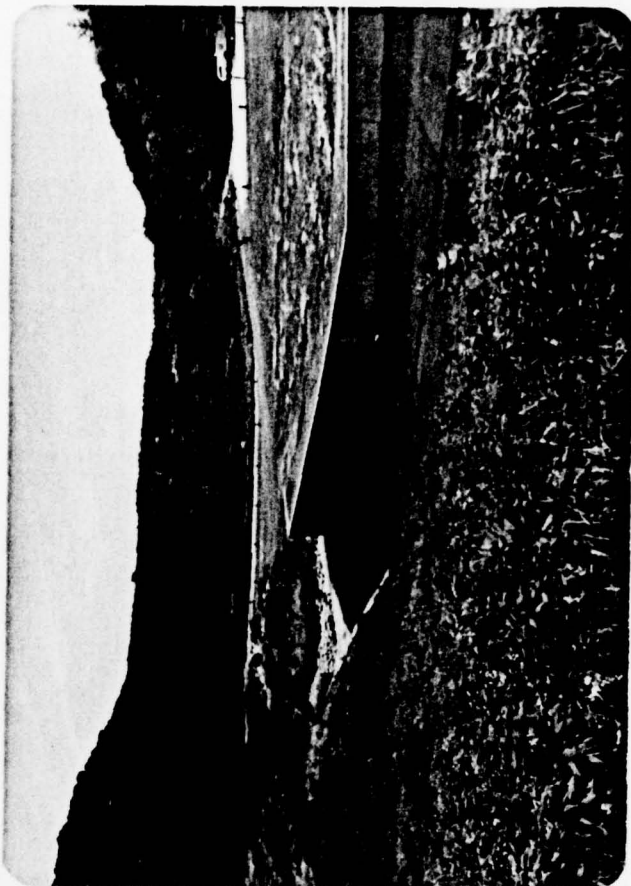
PHOTOGRAPH 8 View looking downstream from the crest of the dam.
